NIST NCSTAR 1-5A

**Federal Building and Fire Safety Investigation of
the World Trade Center Disaster**

Visual Evidence, Damage Estimates, And Timeline Analysis

William M. Pitts
Kathryn M. Butler
Valentine Junker

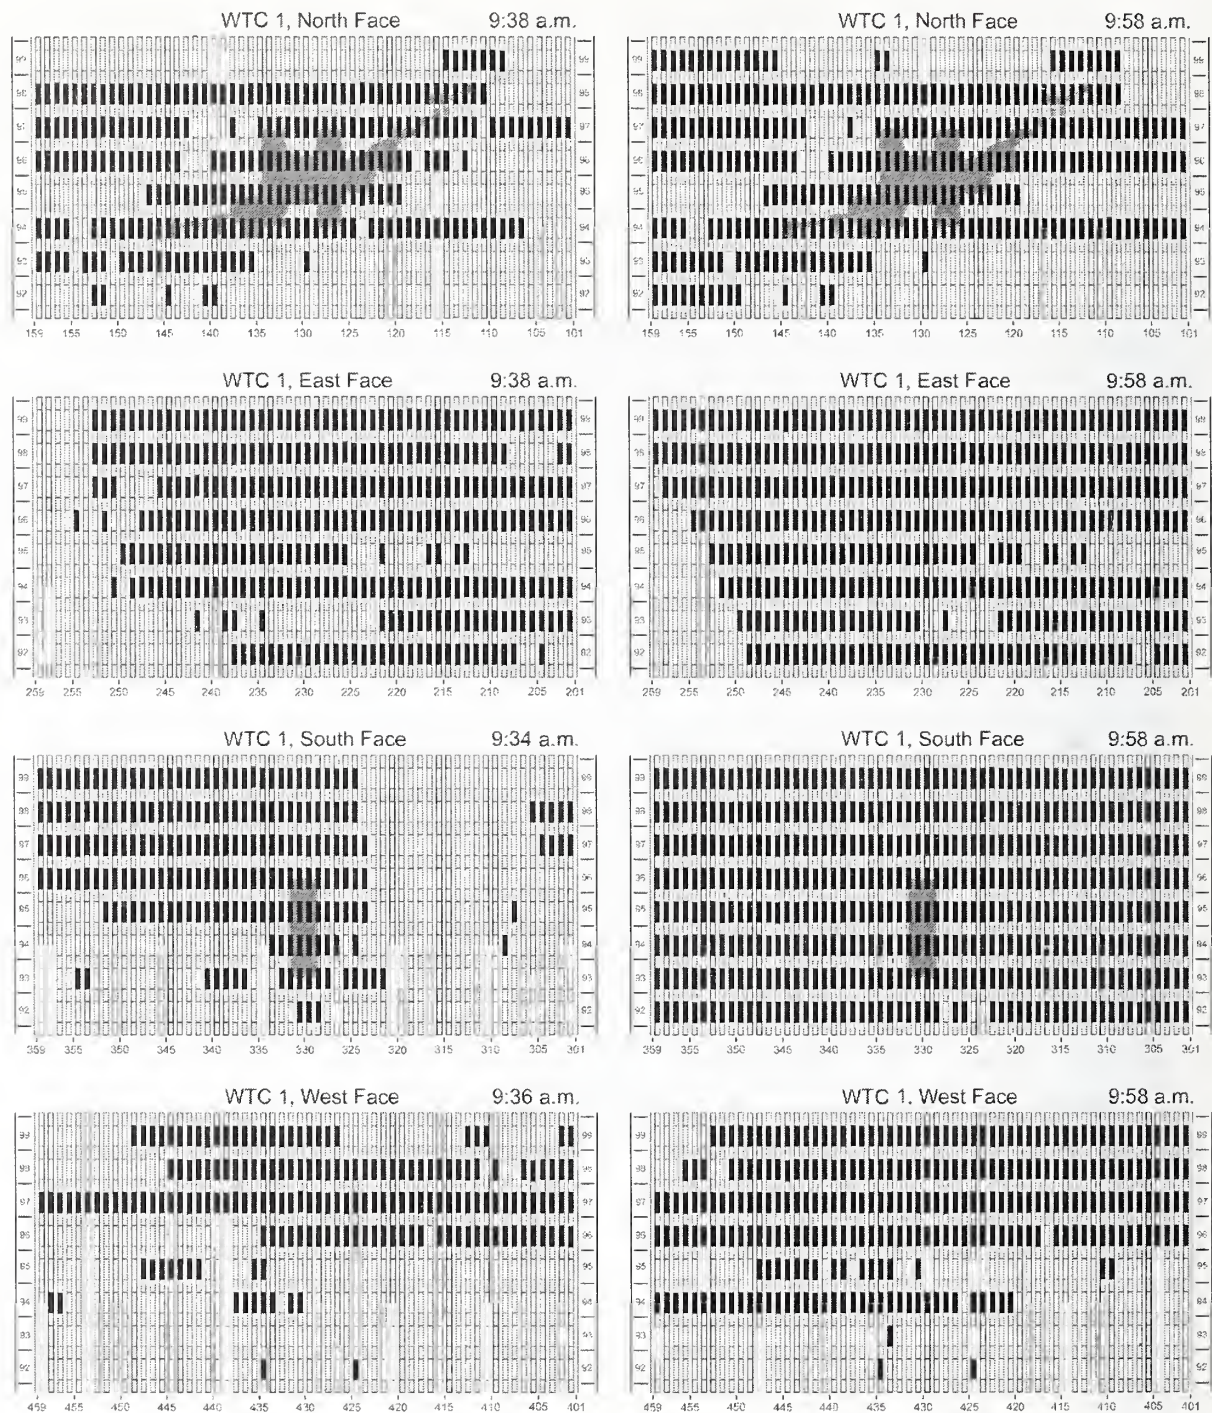
Observed window conditions for the four tower faces at the beginning and end of the period are compared in Figure 8-75. The windows that opened during the period, which generally implies the presence of an active fire, are consistent with the fire-spread observations discussed above. On the north face, windows opened along a long length of the 98th floor and near the eastern edge of the 92nd floor. The growth of the large fire on the east side of the 98th floor is reflected in the large increase in open windows at the later time. On the other floors the fires on the east face appear to be moving relatively deliberately toward the south, but note the large increase in the number of open windows on the 92nd floor. Windows also opened on the east side of the 92nd floor near the north edge. The maps for the south face are consistent with observations that major fire growth during the period was on the 95th and 98th floors. There was evidence of a small fire on the east side of the south face on the 94th floor, but in general, the fires on the south face still have not moved in this direction much beyond the center of the face. Note that most of the windows on the eastern side of the face at the later time are marked as not visible. This is because the imagery available does not allow the conditions of these windows to be assessed. The imagery does indicate that there was no significant smoke or fire coming from windows on the fire floors above the 94th floor. By far, the largest changes in window condition during the period were on the west face. Large numbers of windows have been opened on the 94th, 96th, and 98th floors. These changes are even more remarkable when the nature of the fires, which generally appeared to be gently burning, is recalled.

Figure 8-75. Maps for the 92nd through the 99th floors compare missing window glass for the four faces of WTC 1 at two times, around 9:35 a.m. and at 9:58 a.m. The color coding used for the maps is indicated in Figure 5-1.

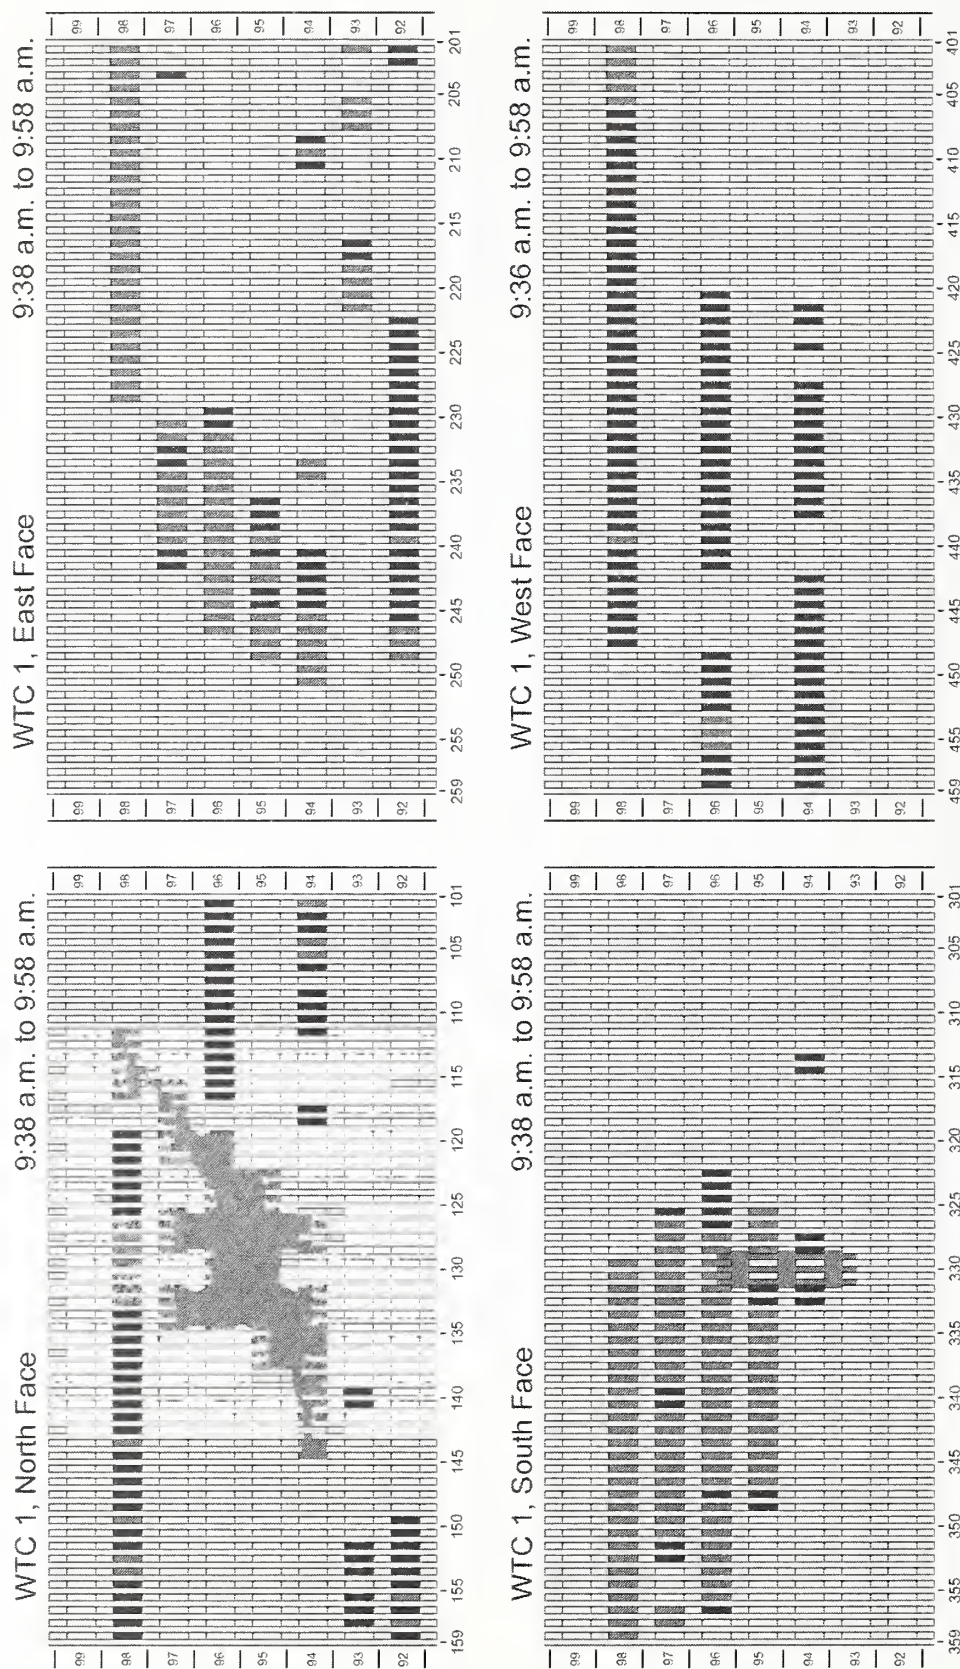
The most distinctive change in the window condition and integrated fire maps between 9:35 a.m. and 9:59 a.m. was the wide-spread appearance of fire on the 98th floor. By roughly twenty minutes after a growing fire first became evident on the north side of the 98th floor, fire was visible on this floor in two long bands. One of these bands started near the center of the south face, ran to the southwest corner and extended north on the west face to at least window 98-444. The second band began near window 98-119 on the north face and ran around the northeast corner to the vicinity of window 98-223 on the east face. The observed fire behavior of these rapidly developing fires varied from face to face. On the east and south faces very intense flames were observed extending large distances from open windows, while on the west and north sides, the fires appeared much less intense and to be burning at interior locations removed from the outer walls. These observations are reflected in the integrated fire distribution maps shown in Figure 8–76.

Figure 8-76. Maps of integrated fire observations between 9:36 a.m. and 9:59 a.m. are shown for the four faces of WTC 1. Colors represent the highest intensity fire observed in a window using the color scale defined in Figure 5-1.

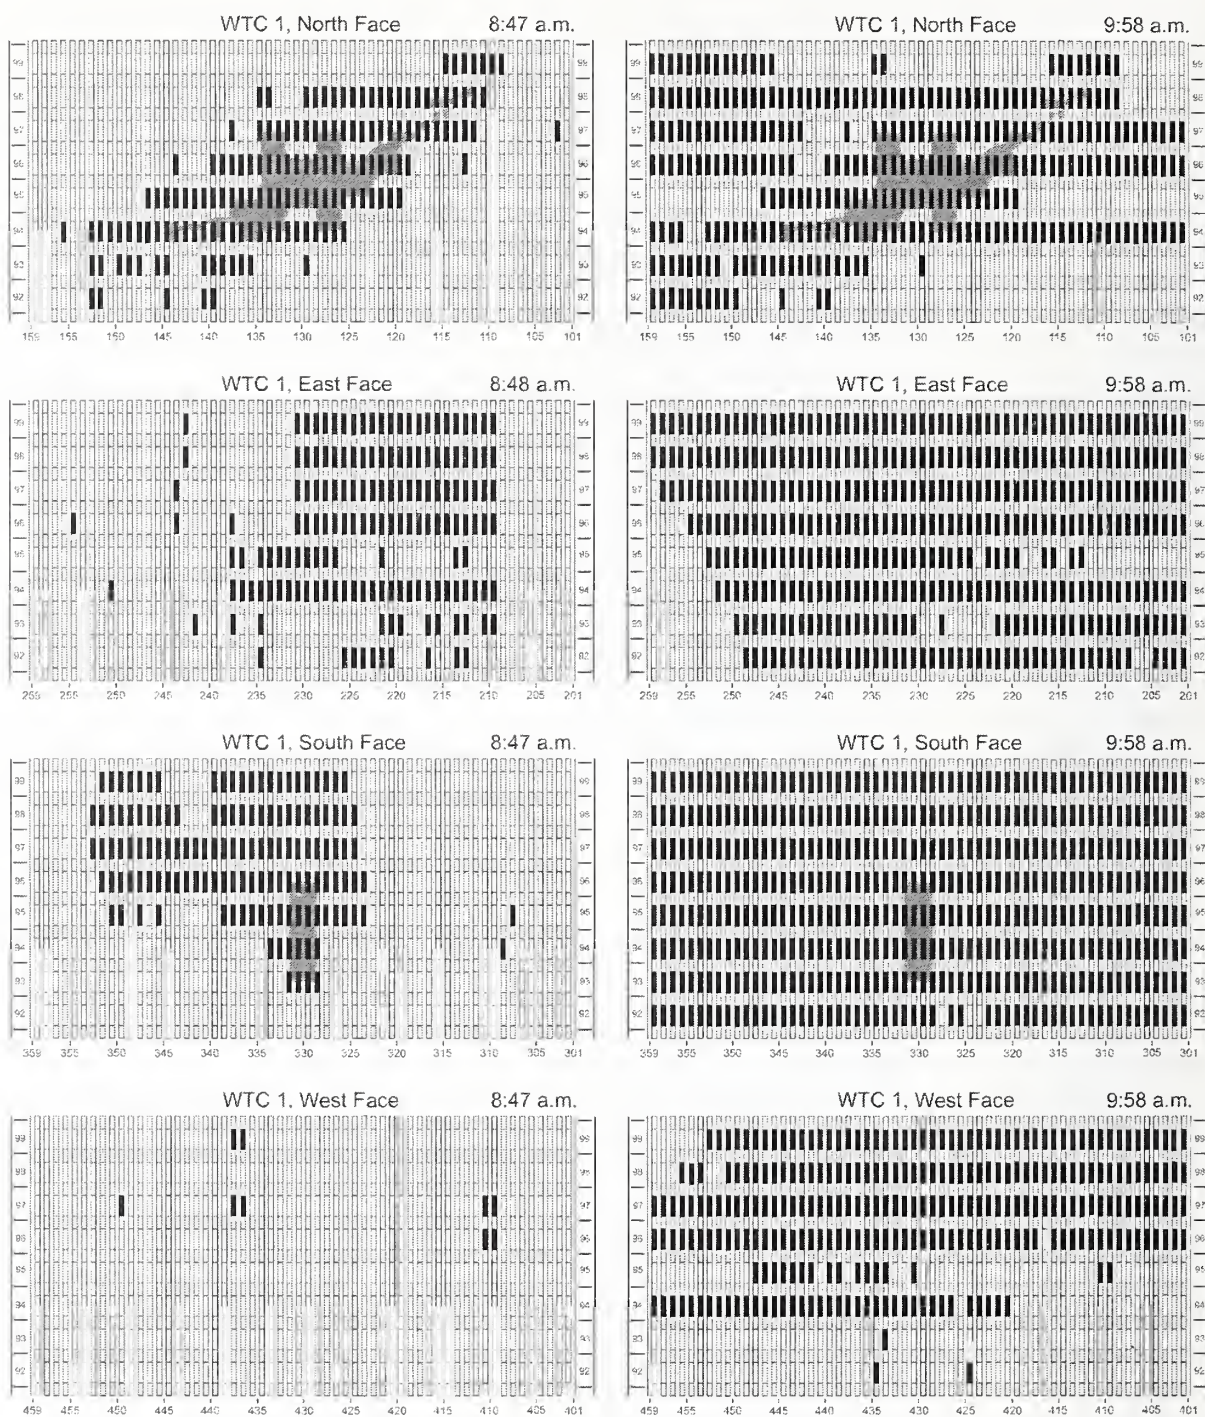
Figure 8-77. Maps for the 92nd through the 99th floors compare missing window glass for the four faces of WTC 1 at two times, immediately following the aircraft impact on WTC 1 at 8:46:30 a.m. and just prior to the collapse of WTC 2 at 9:58:59 a.m. The color coding used for the maps is indicated in Figure 5-1.

The changes in the number of open windows on the individual faces of WTC 1 are consistent with the observed fire behaviors. The largest increases were on the east and west faces. The façade maps in Figure 8–77 show how extensive the fire spread was on these faces during the period under consideration. There was also considerable fire spread observed on the north face, but the percentage increase in the number of open windows is smaller due to the large number of windows that were opened when the aircraft struck. The smallest increase in total open windows was for the south face. This reflects the fact that the fires did not migrate substantially into areas on the eastern side of this face during the 1 hr and 13 min period.

The total number of windows opened by the fire is remarkable. The number increased by nearly a factor of four as compared to the number of windows that were broken open immediately following the aircraft impact and subsequent fireballs. This represents an increased total open area of just over 8,300 ft². This large area of open windows substantially increased the amount of outside air available for the fires. This suggests that there was a very strong interaction between the breaking open of the windows and the observed fire spread and growth behavior.

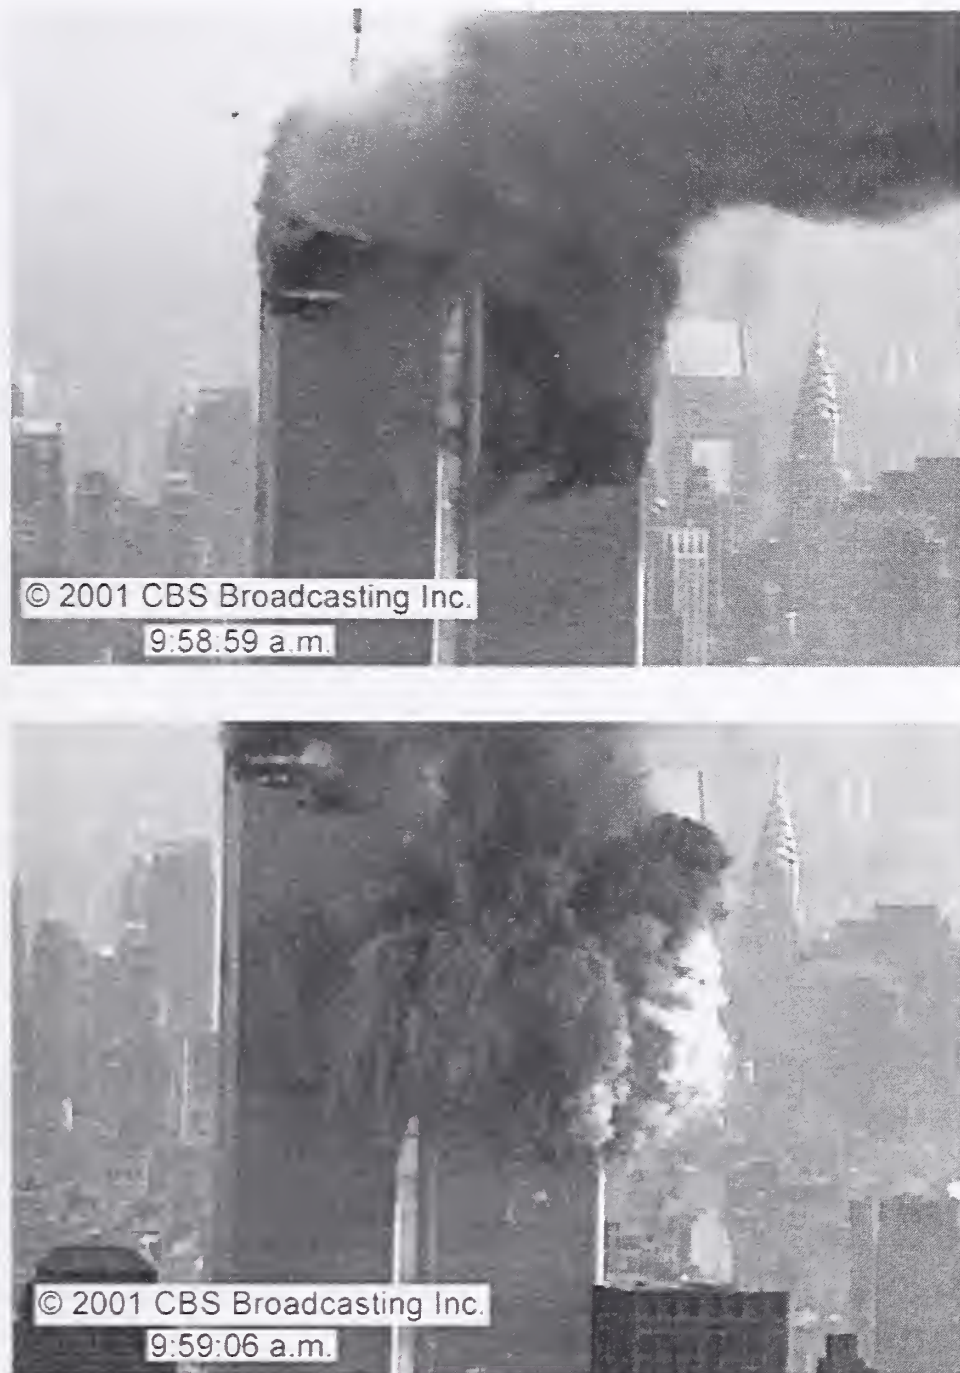
At 9:58:59 a.m. WTC 2 began to collapse, and roughly ten seconds later debris reached the ground. Very shortly after the collapse began, fire and smoke were pushed out of the south face of WTC 1. Figure 8–78 contains two frames taken from a video showing the south faces of the towers. The first frame was recorded just as WTC 2 began to collapse, and the second was shot seven seconds later. In both frames the fire burning on the 98th floor of WTC 1 is very distinct. At the earlier time there does not appear to be external flames, but in the second frame long flames extend from near the center of the face. Review of the video indicates that these flames were pushed out of WTC 1 starting four seconds after collapse initiation. Closer inspection shows that an area of flame is visible on the western side of the 96th floor at the later time that was not evident seven seconds earlier. It is significant that flames do not appear elsewhere on the face at the later time, perhaps indicating that large flames are only present near the periphery of the face at these locations.

Figure 8-78. Two frames taken from a video shot from a news helicopter show the south face of WTC 1 just as WTC 2 starts to collapse at 9:58:59 a.m. and 7 seconds later. WTC 1 and WTC 2 are to the left and right, respectively. Images have been enhanced by adjusting the intensity levels.

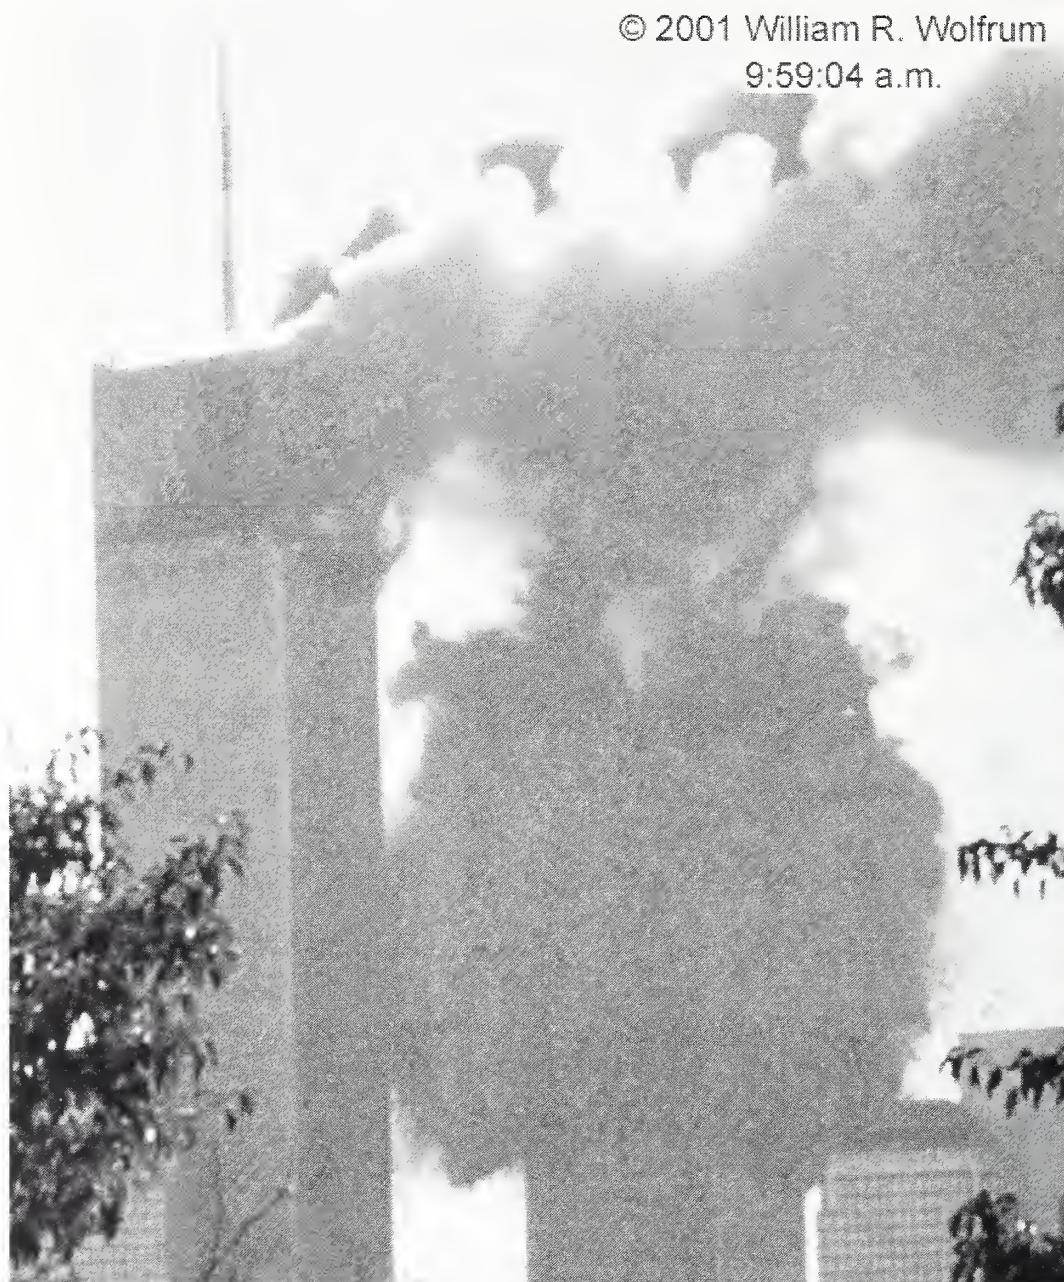
Figure 8-79. This cropped photograph was shot from the southwest and shows WTC 1 and the collapsing WTC 2 at 9:59:04 a.m. The image was enhanced by adjusting the intensity levels, and some bright areas are saturated.

Figure 8-79 includes a photograph that was shot at 9:59:04 a.m. and shows the flames coming out of the 98th floor windows while WTC 2 collapses nearby. Flames have also been pushed out of open windows on the 96th floor near the western edge of the south face. Fires are also visible on the west face of WTC 1 on the 94th, 96th, and 98th floors, but flames are not visible outside of the windows. In the photo it appears as if debris from WTC 2 is either striking WTC 1 or just passing by on the east side.

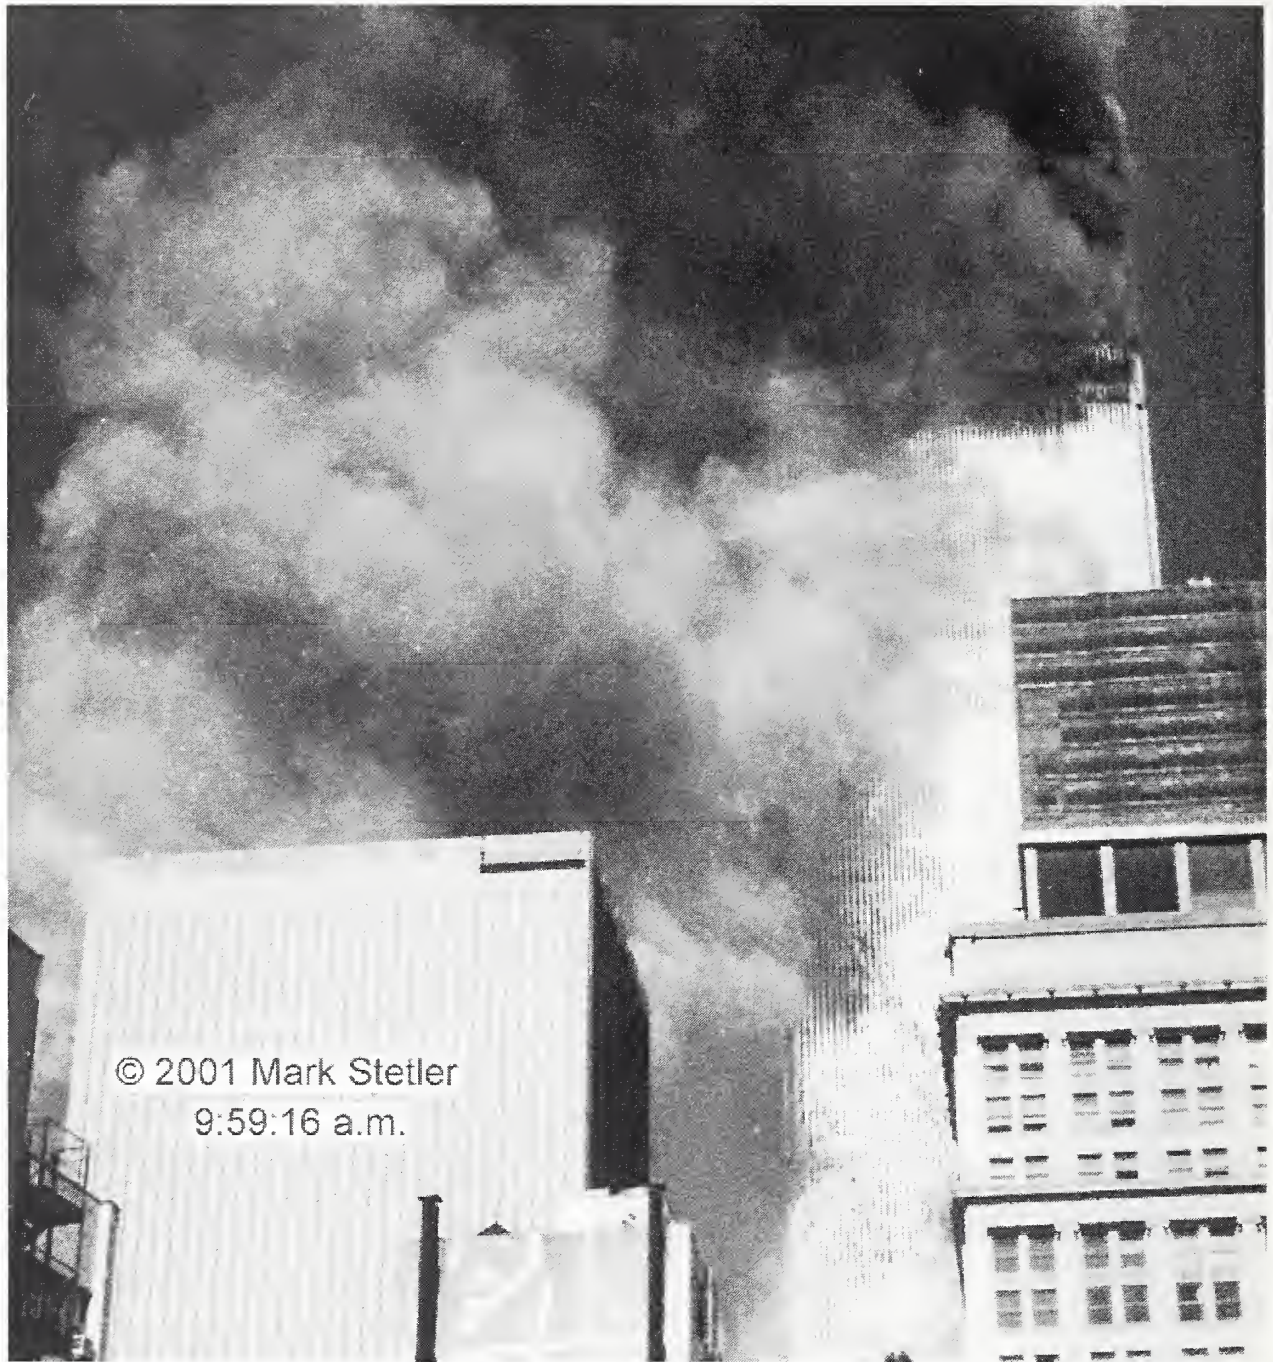
Videos shot from the east show that debris from WTC 2 did indeed pass in an arc across the east face of WTC 1. The damage created by this debris to the façade of WTC 1 can be seen in Figure 8–80 near the bottom of the photograph. This damage was only visible for a short period before dust rose upward from below and hid the area. The highest marks on the building are just below the mechanical equipment room on the 75th and 76th floors. The damage appears relatively superficial, and it is considered unlikely that it affected the subsequent fire behavior. Videos and eyewitness accounts indicate that large amounts of dust and some debris entered the lower floors of WTC 1 during the collapse of WTC 2. It is not known if damage at these lower locations could influence the fires near the top of the tower, but it seems unlikely.

Figure 8-80. This cropped photograph shows the east face of WTC 1 at 9:59:16 a.m., i.e., 17 s after WTC 2 began to collapse.

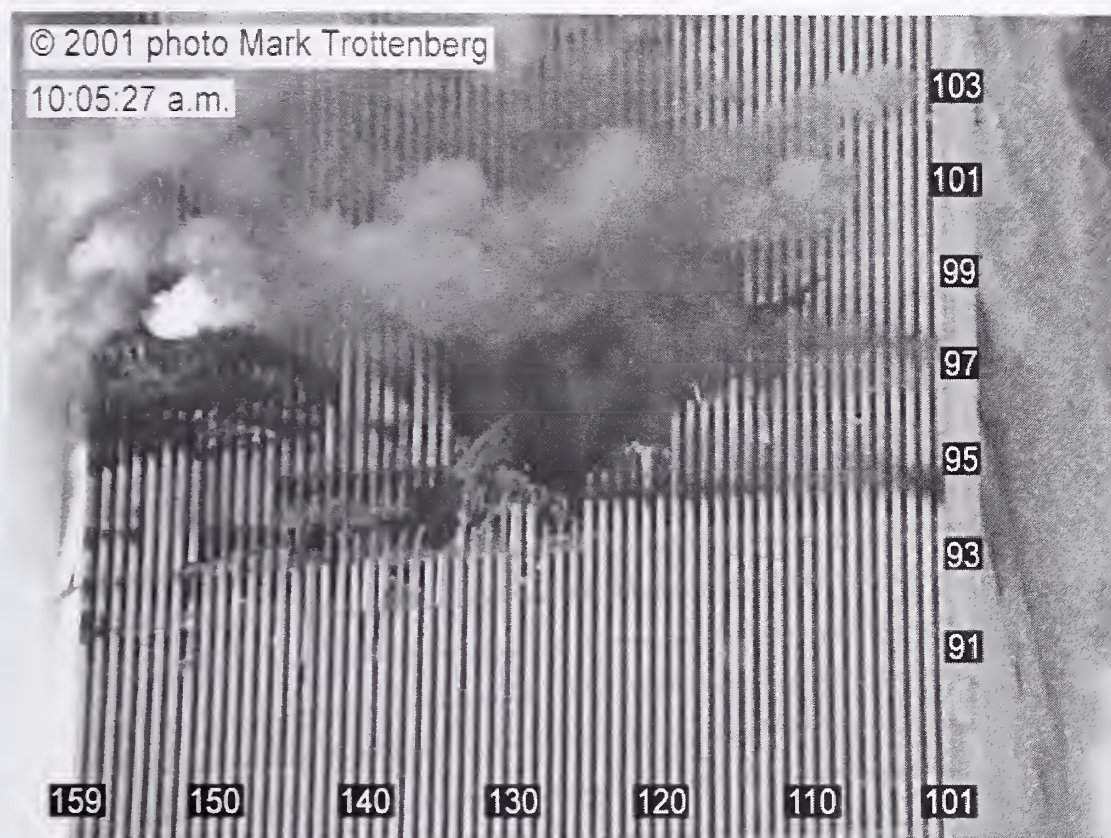
The most complete information during the current period is available for the north face of WTC 1. A view of this face at 10:05:27 a.m. is shown in Figure 8–81, which is a frame captured from a video. Remarkably little fire is visible in the image. Small flames are present near windows 92-146, 96-106, and 98-152. More extensive fires were evident at each of these locations at 9:57:59 a.m. (see Figure 8–55). Apparently, these fires had died down in the intervening seven and a half minutes.

Figure 8-81. This view of the north face of WTC 1 was captured from a video recorded at 10:05:27 a.m. The image has been enhanced by adjusting the intensity levels. Column and floor numbers have been added.

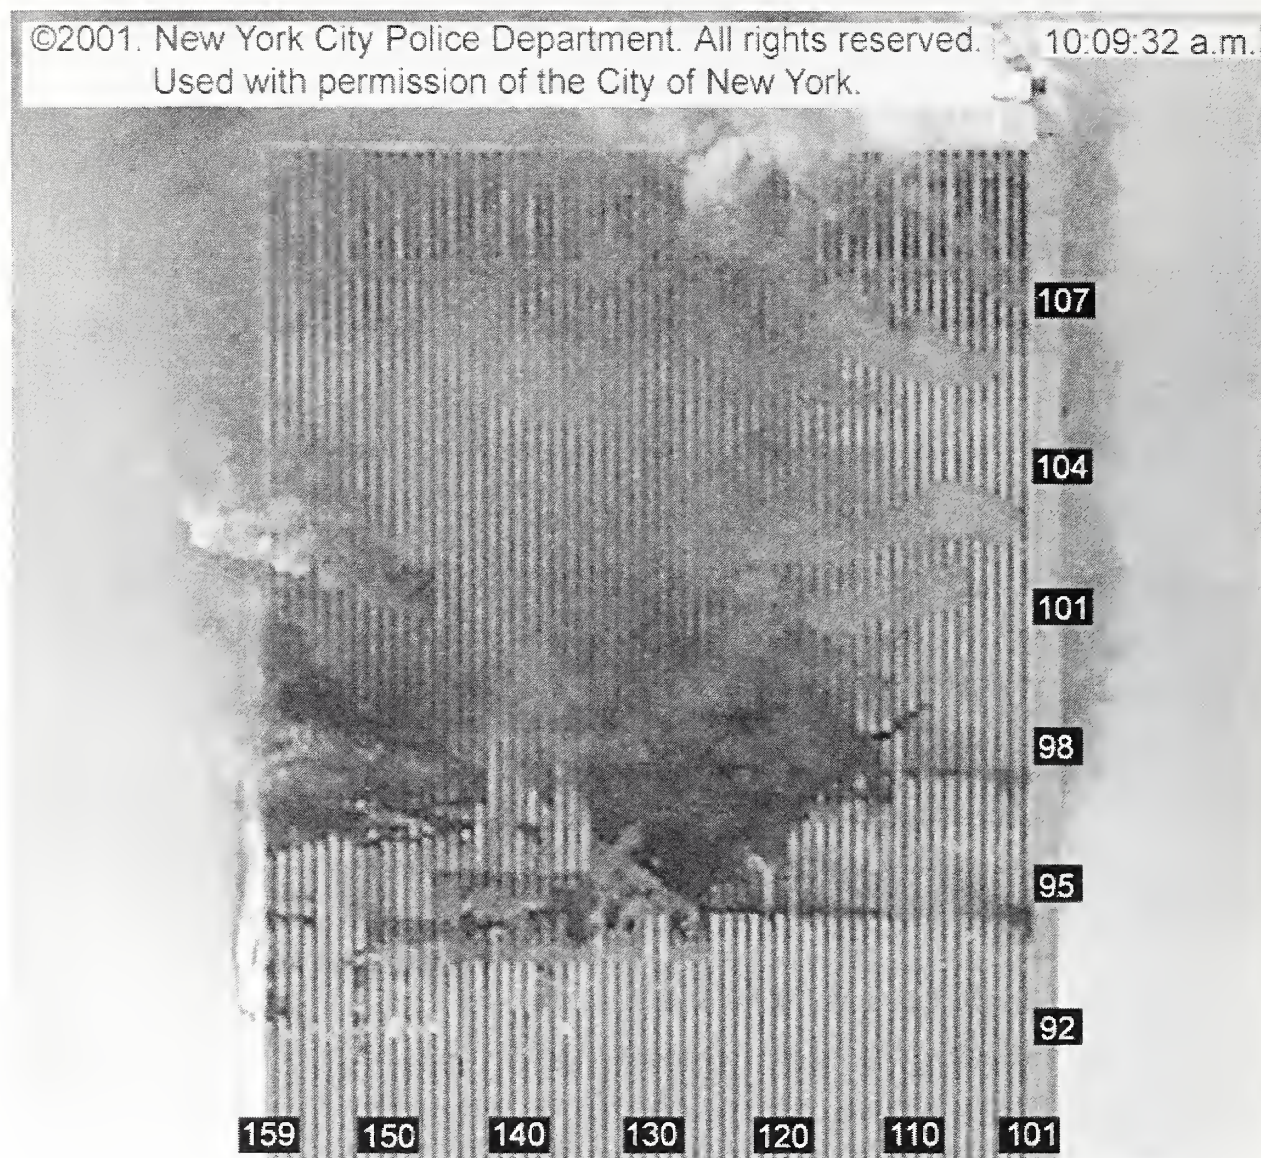
The photograph shown in Figure 8–82 was shot from a helicopter looking down on the north face of WTC 1 at 10:09:32 a.m. Considerably more flame is visible than could be seen in Figure 8–81. The difference is due to the angles from which the images were taken. The video frame shown in Figure 8–81 was taken from the ground a few blocks away from the WTC site, while the photograph in Figure 8–82 was shot from a much greater distance looking down into the windows. In effect, the latter photograph is looking much deeper into the building. On the 92nd floor a length of flames is evident extending from the eastern edge of the tower to window 92-146. At 9:57:59 a.m. flames were only visible as far as window 92-149. Windows further to the west were still intact. The fire has moved into the room that has walls terminating at columns 92-146 and 92-149 (see Figure B-1).

Low intensity fires are also visible in Figure 8–82 on the west sides of the 94th and 96th floors and over much of the eastern half of the 98th floor. These are locations where much larger fires were present at earlier times, and these fires are likely the remnants. They were not visible from the ground around this time because they were low intensity and were burning near the floors, where they were hidden from view.

In Figure 8–82 there is no evidence of fire on the north face near the west edge of the 98th floor. At 10:10:15 a.m. a burst of heavy smoke was released from window 98-105, and less than two seconds later smoke came from window 98-102. A series of photographs taken around this time indicates that fire appeared in window 98-102 between 10:10:19 a.m. and 10:10:20 a.m. A photograph recorded at 10:10:55 a.m. showed flames were present in windows 98-101 to 98-108 and that flames were coming from windows on the adjacent west face.

Figure 8-82. This cropped photograph was shot from a helicopter looking down on the north face of WTC 1 at 10:09:32 a.m. The intensity levels have been adjusted and column and floor numbers have been added.

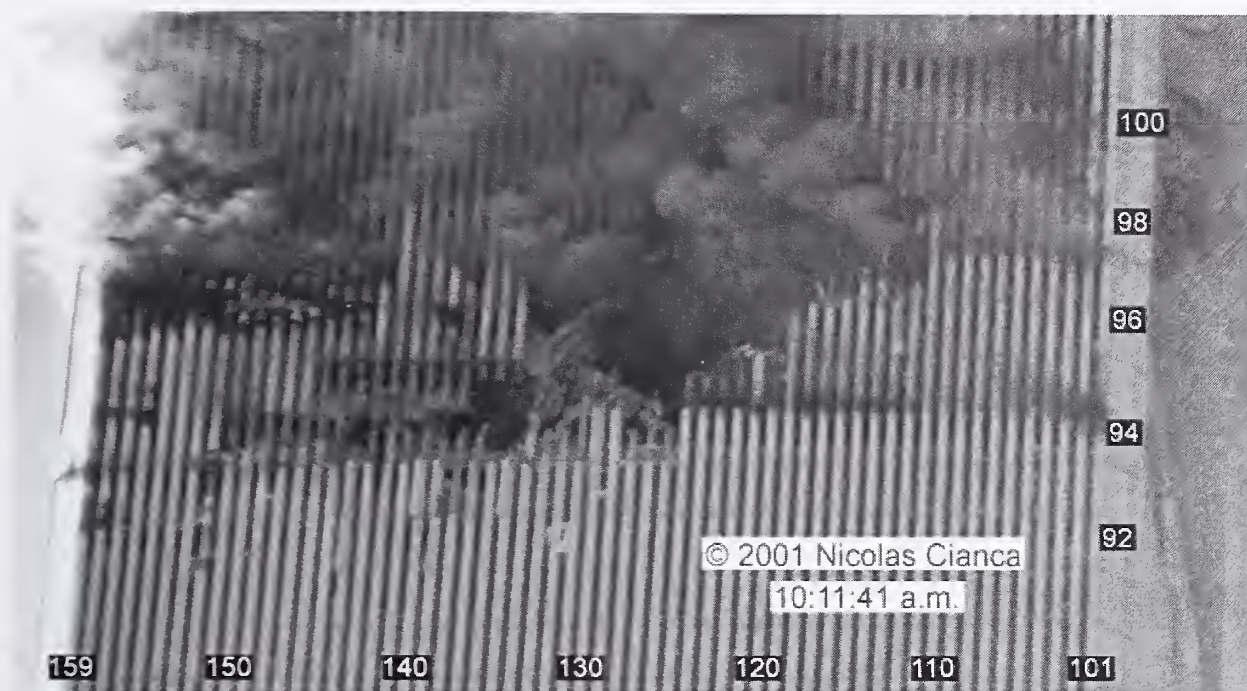
Figure 8-83 shows the north face at 10:11:41 a.m. The fire at the western edge of the 98th floor is visible in windows 98-101 to 98-110. On the 92nd floor there are bright flames present in windows 92-131 and 92-132. These two windows are on the west side of the room on this floor that has walls ending at columns 92-132 and 92-138 (see Figure B-1). The windows to the west of this point appear to still have glass in place. There appear to be some small fires on the east side of the 92nd floor, but flames are not observed elsewhere from this vantage point.

Figure 8-83. This photograph shows the north face of WTC 1 at 10:11:41 a.m. The original image has been cropped, rotated, and adjusted for intensity levels. Column and floor numbers have been added

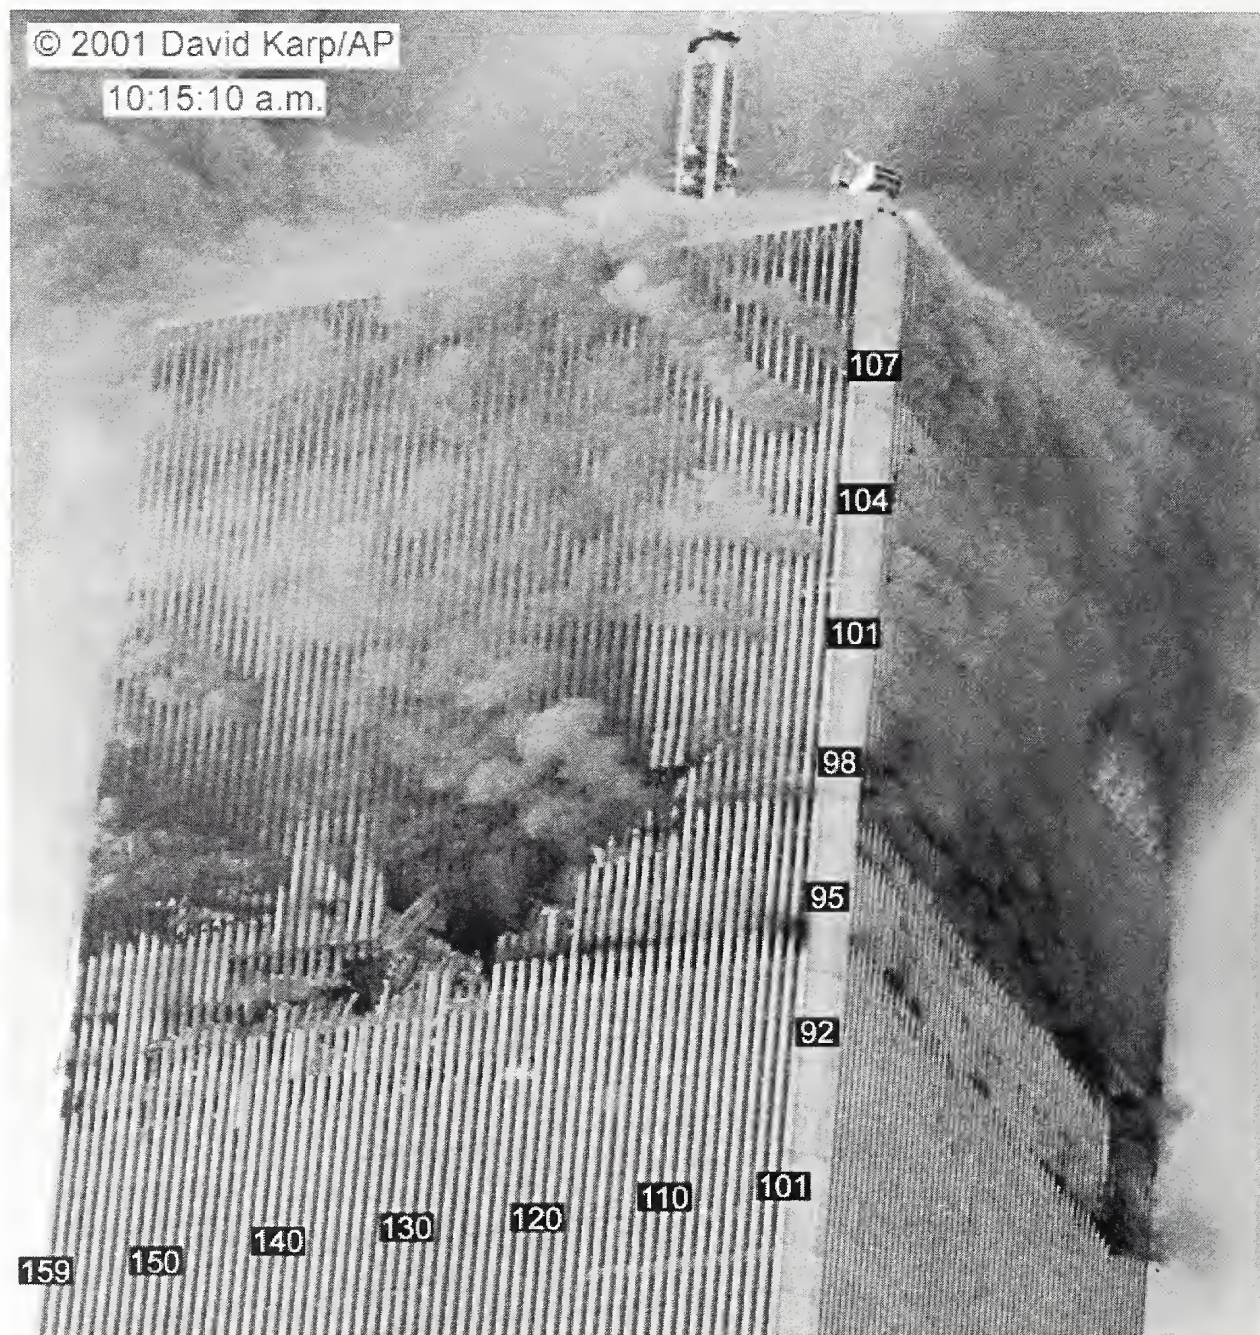
A view of WTC 1 shot from the northwest at 10:15:10 a.m. is shown in Figure 8-84. The fire on the north face of the 92nd floor has grown and moved toward the west. Flames are now visible as far west as window 92-121. As seen in Figure B-1, there was a large open area on the 92nd floor that ran between walls that terminated at columns 92-105 and 92-132. A fire is now burning on the east side of this open area, having apparently appeared in the room around 10:11:14 a.m. (see Figure 8-83). At the time the photograph in Figure 8-84 was taken, the glass for windows to the west of column 92-121 still appeared to be in place. It is interesting that even though a fire was growing in the area, there was no smoke coming from the open windows. This must be another case where the smoke was venting elsewhere.

Figure 8-84. This photograph of WTC 1 shows the north and west faces of WTC 1 at 10:15:10 a.m. The image has been cropped and rotated, and the intensity levels have been adjusted. Column and floor numbers have been added.

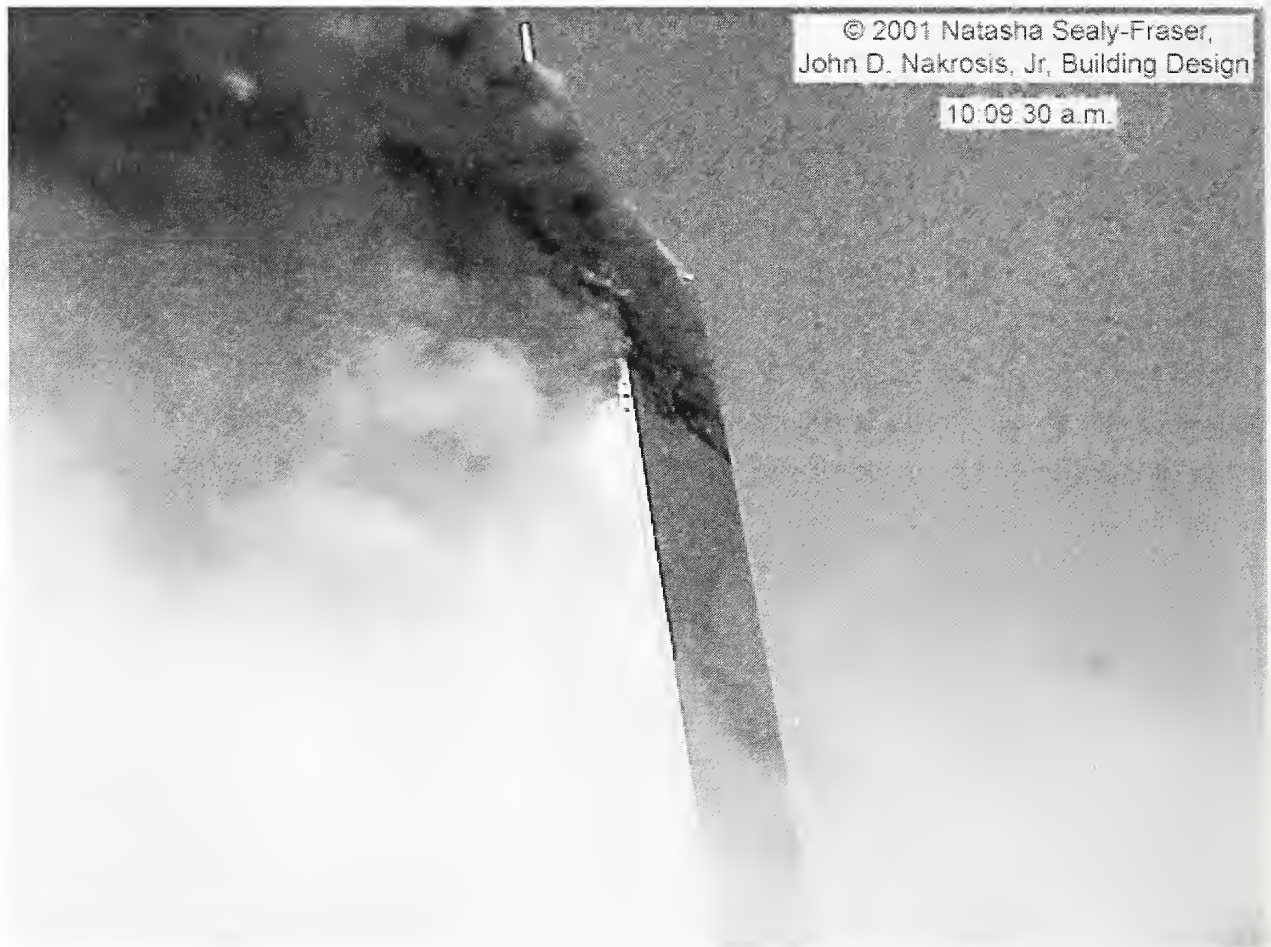
Figure 8-85. This photograph shows the east and north faces of WTC 1 at 10:09:30 a.m. The intensity levels have been adjusted.

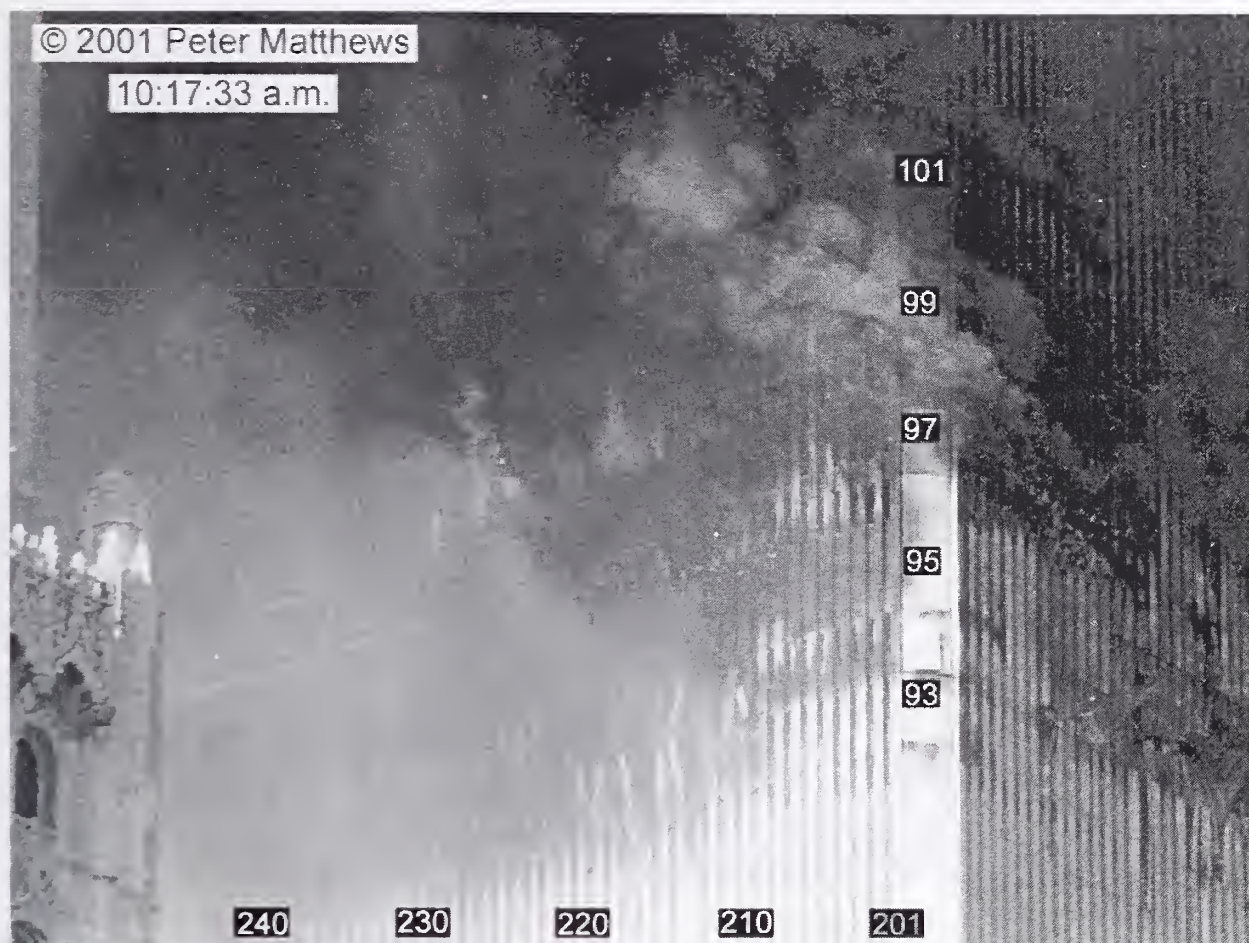
Flames are also visible on the 96th and 97th floor extending south from near windows 96-240 and 97-240 to the last windows (96-245 and 97-245) that can be seen in the image. Closer inspection of Figure 8–86 shows what appears to be a small fire on the 101st floor near window 101-224. There is some ambiguity

because of the flames coming from below, but the fire visible higher up seems to be well isolated. This observation suggests that fire has spread upward on the east face by jumping over a couple of floors.

Figure 8-86. This photograph shows the north and east faces of WTC 1 at 10:17:33 a.m. The original has been cropped and enhanced by adjusting the intensities. Column and floor numbers have been added.

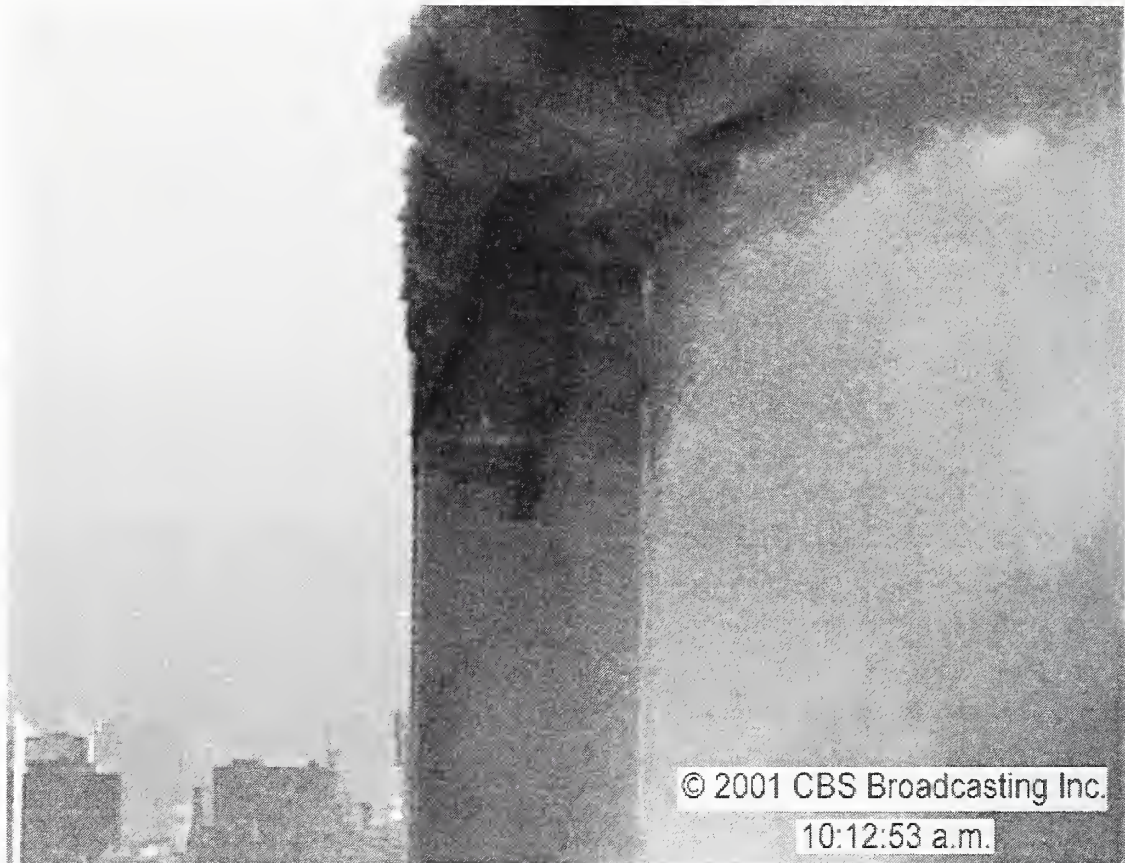
Figure 8-87 shows one of the clearer views of the south face captured from the news helicopter video. It was shot at 10:12:53 a.m. With one major exception, fires are distributed much as described above. The bright flames on the east sides of the 96th and 97th floors and the west side of the 98th floor are easily seen. In addition, an intense jet of flame is apparent on the west side of the face. This external flame, which is over a story tall, appears to be coming from the 99th floor. This is an indication that the fires had now progressed upward to this floor. Near the center of the face, there is a smoke plume coming from one of the lower floors. It is difficult to be sure, but this smoke appears to be coming from the 92nd floor. If correct, this suggests that a fire was burning on the south side of the 92nd floor.

Figure 8-87. This view of the south face of WTC 1 was captured from a video recorded by a news helicopter at 10:12:53 a.m. The image has been enhanced by adjusting the intensity levels.
